Ins & Outs of Water Storage Tanks

Chipman Road (High Service) Ground Storage Tank

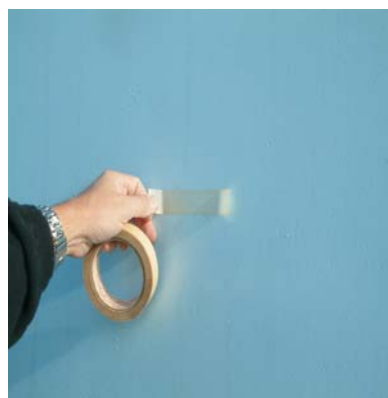
Holidays are pin holes or voids formed in the paint on metal surfaces. If the top coat has not properly covered the metal, it can easily be detected by Holiday Testing.

Holiday testing uses a wet sponge attached to a low-voltage regulator. Wiping the sponge across the tank surface, the wet sponge comes in contact with the metal. If there are any imperfections in the finish coat surface, the tester will send out an audible tone. When imperfections are detected, Larkin's staff will mark them so the paint contractor can properly refinish the surface.
